The January 17, 1994, Northridge Earthquake, California

H. S. Lew¹, Jim Cooper², Sam Hacopian³, Walter Hays⁴, and Mike Mahoney⁵

ABSTRACT

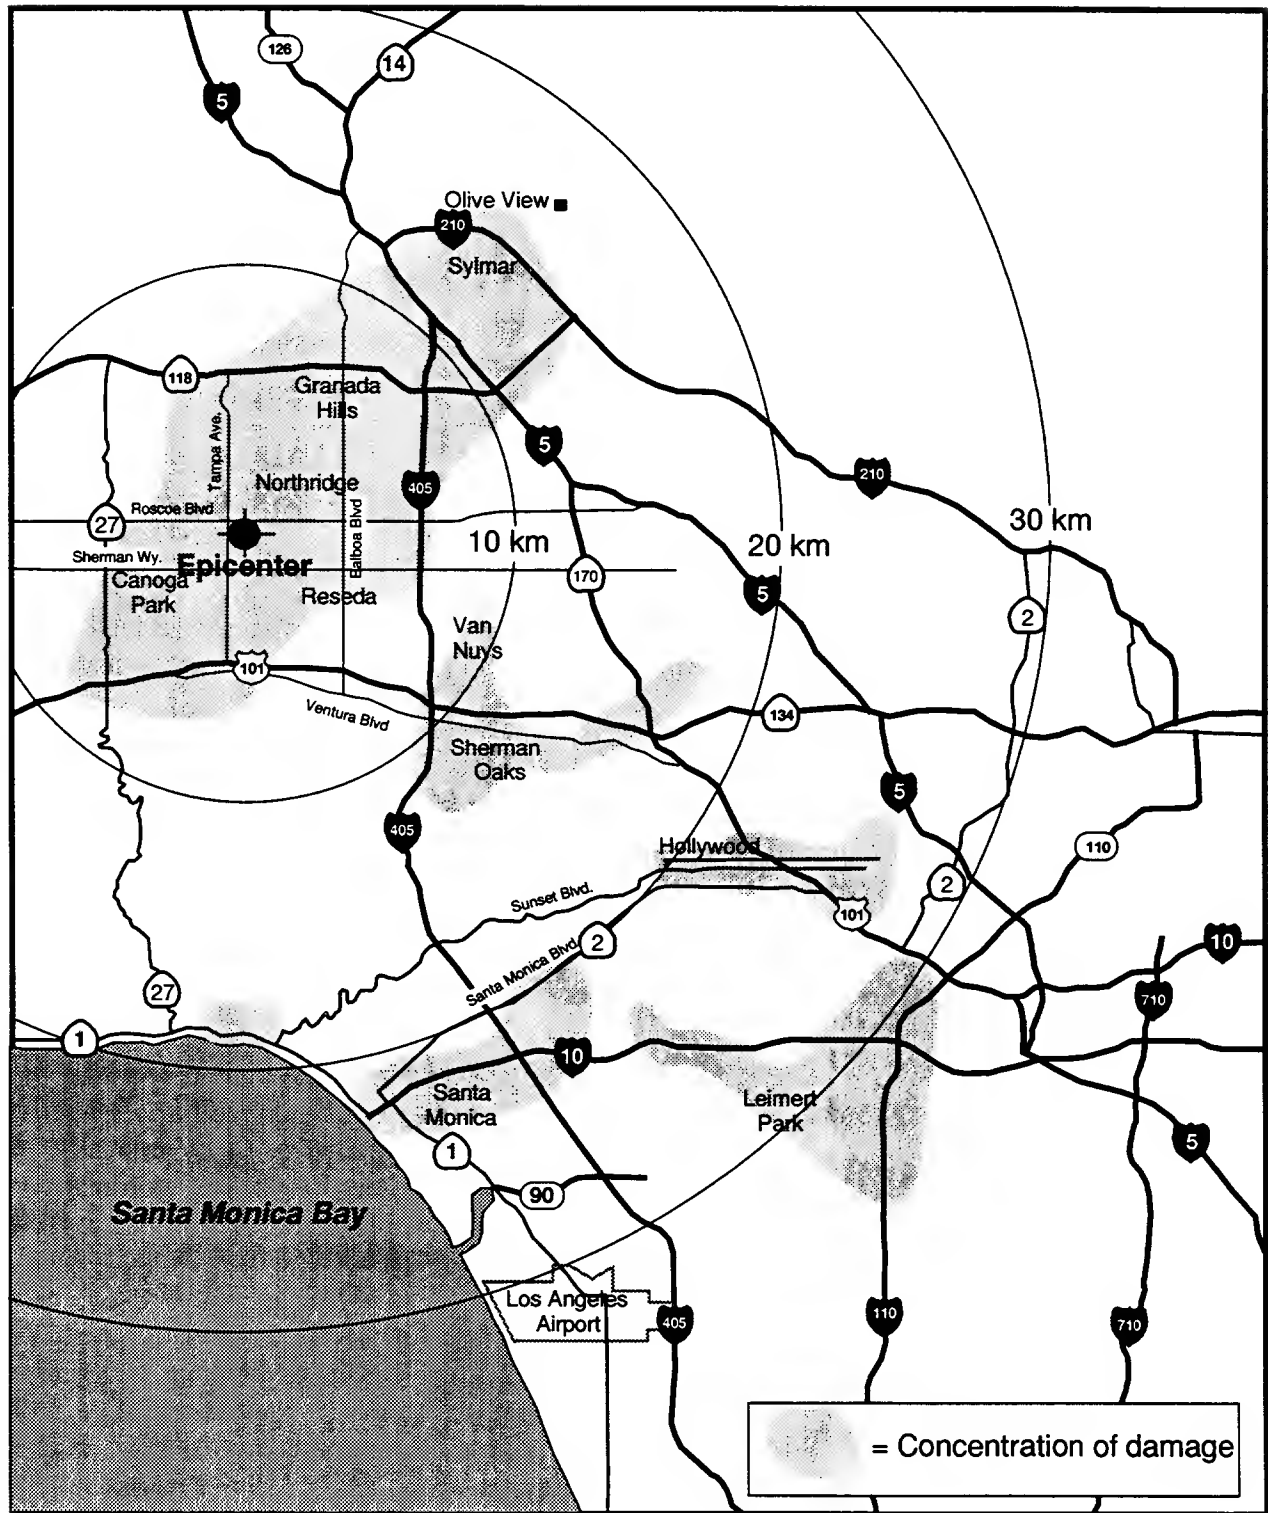
Figure 4 Serious damage to buildings caused by the magnitude 6.8 Northridge earthquake was widespread, but, outside of the epicentral area, seriously damaged buildings tended to occur in pockets.

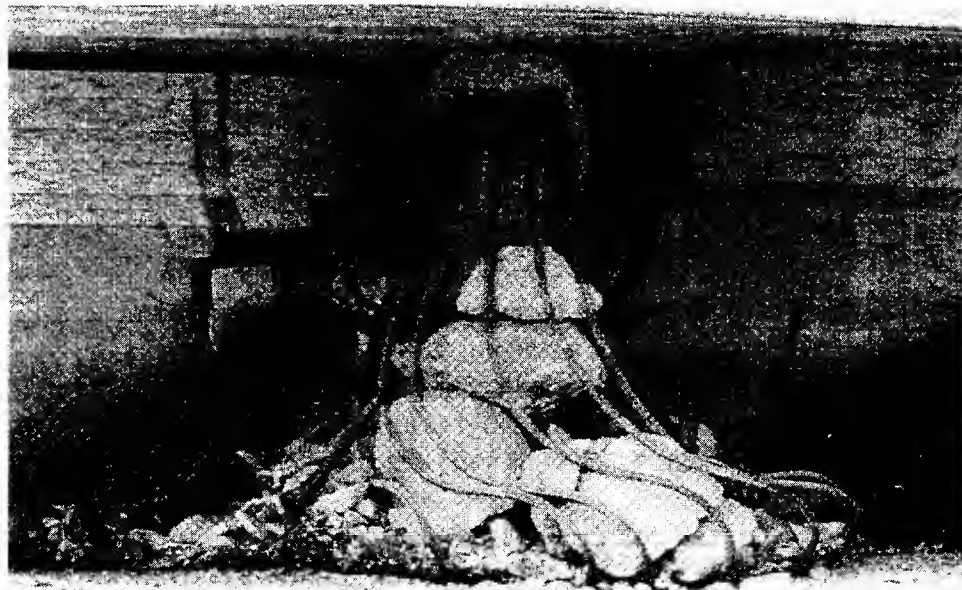
Figure 38 Failed piers in Bent 7 supporting westbound lane of I10 at Venice Blvd.

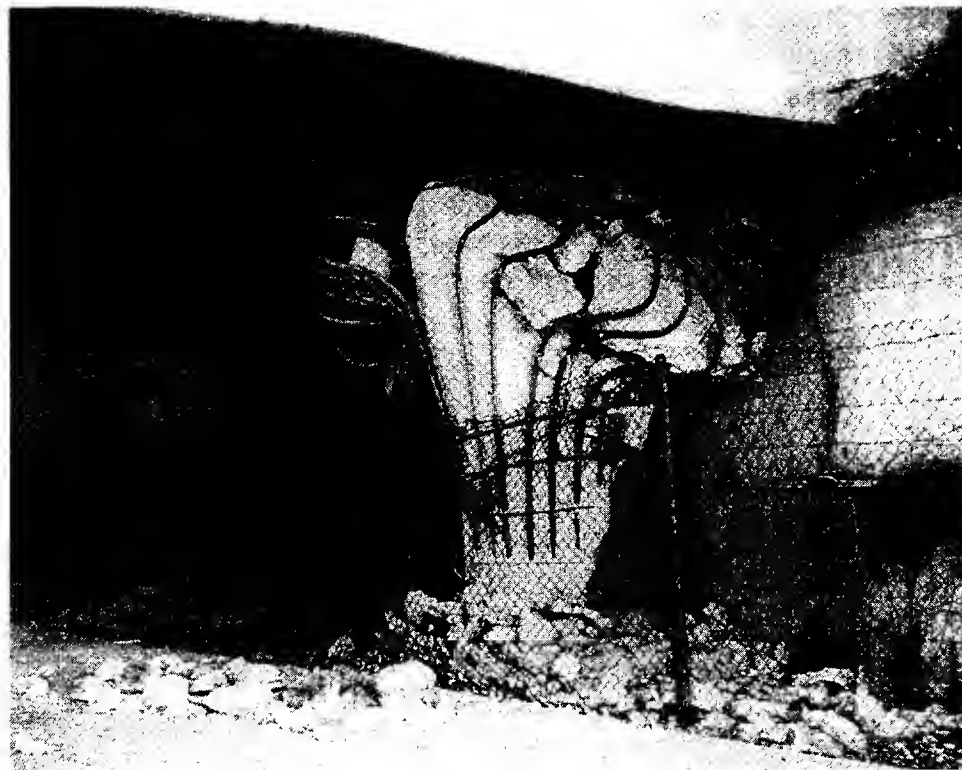
Figure 39 shows the northernmost pier of Bent 6, located just to the west of the hinge. This pier totally disintegrated, but the storage building prevented the roadway from collapsing to the ground. Figure 40 shows the southernmost pier supporting the

Figure 39 Northernmost pier of Bent 6 supporting westbound lane of I10 (west of Venice Blvd.)

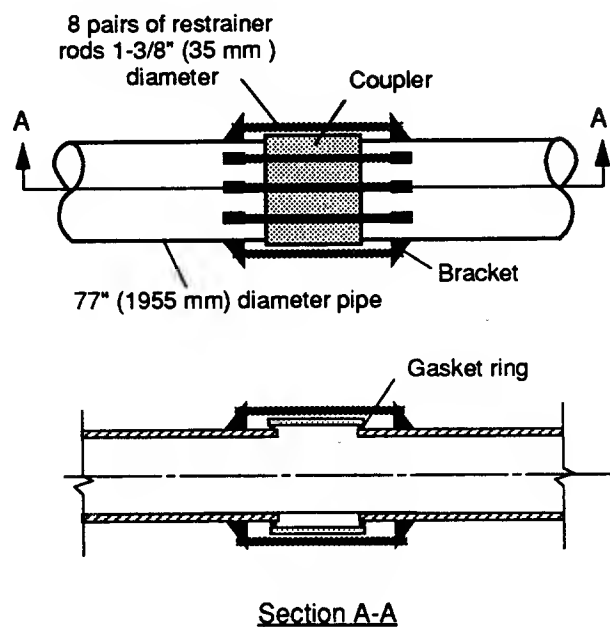
A steel pipe brings water up from the canyon below (Figure 44). The pipe is supported on concrete saddles built along the mountain slope. In a few places, the pipe separated from the saddles creating 50 to 80 mm gaps. In at least one location, the pipe crashed into the saddle. In two other locations, the pipe sections bulged 80 mm and 150 mm respectively. However, no rupture or leakage was noticed. The ruptured section of the 2.1-m pipe is located near top of the hill. The two sections where the rupture occurred were connected together using a mechanical coupling system (Figure 45). To restrain the relative movement between the two pipe sections during strong shaking, the sections were connected by eight pairs of restrainer rods 35 mm in diameter and 2.2 m long. The rods were attached to brackets, which were welded to the pipes. These welds broke due to strong shaking and resulted in the separation of the two pipe sections.

Figure 44 The steel pipeline at Terminal Hill separated from its supporting saddle at several places and pipe sections bulged at other locations along the alignment.

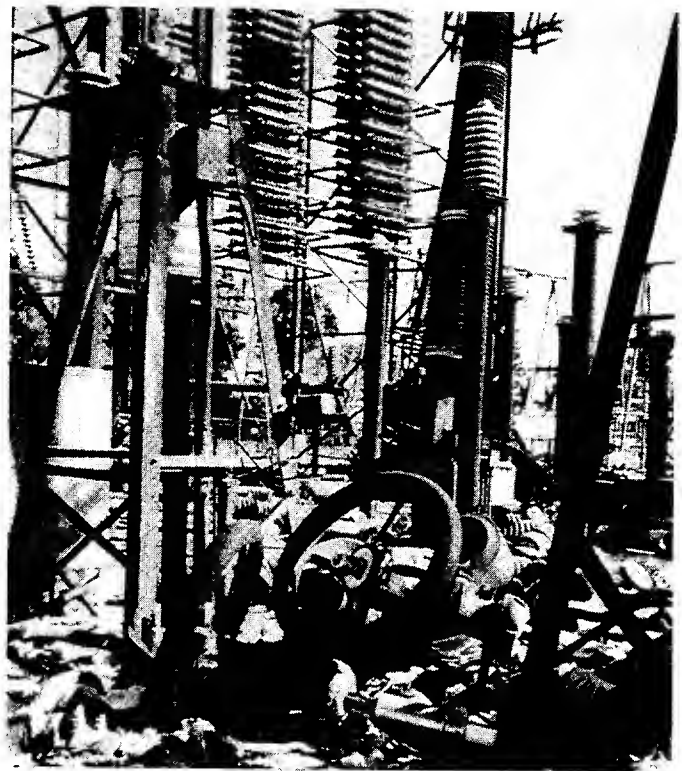
Figure S1 Damage to DC equipment at several high voltage substations, such as this one at Sylmar, led to widespread power outages in the Los Angeles area as well as isolated outages throughout seven western states. (Photo courtesy of Edward Matsuda, Pacific Gas and Electric Company.)

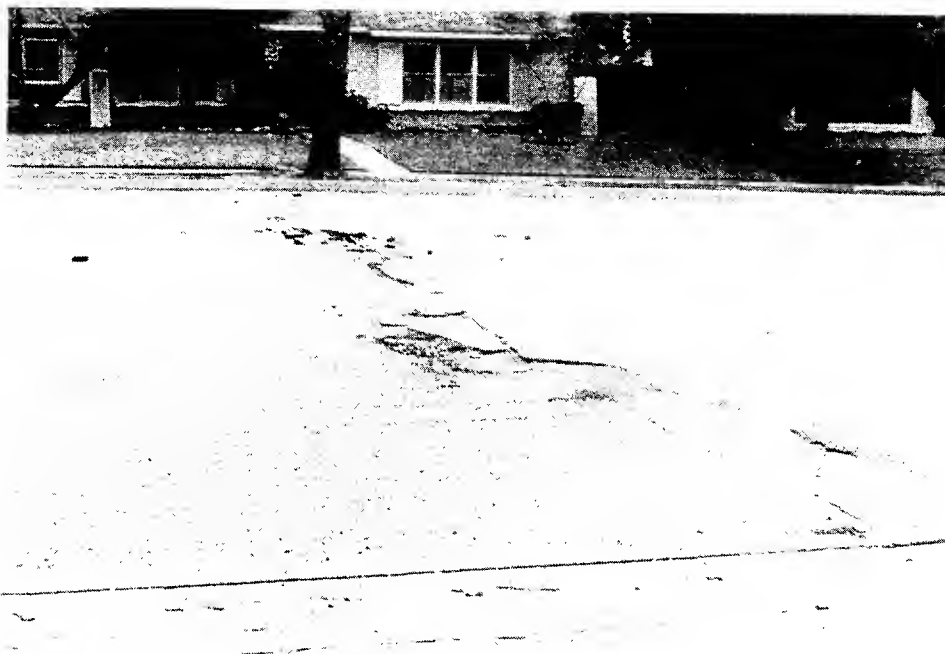
Strong ground shaking and lateral movement of subgrade materials resulted in numerous ruptures of asphalt pavement and concrete sidewalks in the epicentral area (Figure 55). In some instances, local traffic was interrupted temporarily waiting for the repair of these cracks. In most cases, the damage was minor and local traffic was not interrupted. The south approach of Balboa Boulevard at SR118 caved in from loss of abutment fill due to a water main break. This bridge was closed for traffic due to some structural damage to the piers and the loss of the south abutment fill.

Figure 55
Transverse cracks
in pavement along
Balboa Boulevard
in Northridge area.
